SeaCast, Inc.

RCRA Compliance Evaluation Inspection WAD 98176 9805

January 31, 2012

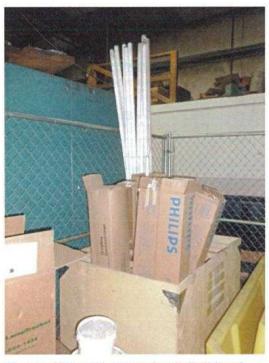
Photo 6: Universal waste tubes in Building 2 accumulation area

In the back corner of the fenced accumulation area we observed several boxes of fluorescent lamps/tubes (photo 6). These tubes were in four foot long cardboard boxes that were placed upright (perpendicular to the floor) in a large wooden box; all of the boxes were open. At least one box contained tubes that were longer than the box and one of the boxes had a broken tube in it. Inside the top of the wooden box a grid had been created using 1x1 dimensional lumber to create supports of the boxes of lamps to remain upright. On the exterior of the wooden box, facing the back fence of the area, the words "Used Bulbs" had been spray painted in black letters. Mr. Truscott confirmed that all the lamps in the wooden box were used. We did not observe start dates on any of the cardboard boxes and Mr. Truscott said that they did not have a record of when accumulation had begun.

- 3. The fluorescent lamps were not in closed containers and were not labeled with the words "universal waste" or accumulation start dates. We were not made aware of any other way the facility was using to track the accumulation start date for the lamps.

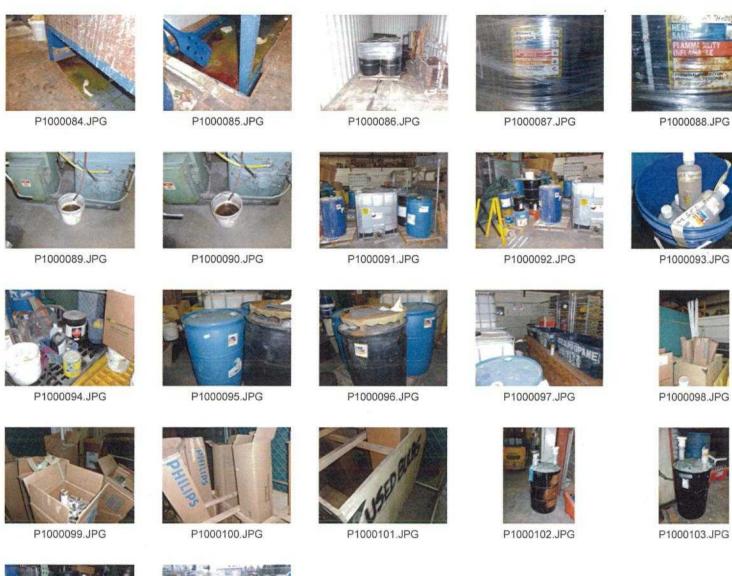
P1000104.JPG

P1000104.jpg Container of used oil generated from air compressor
